Exhibit M

THE INSTALLATION AND PERFORMANCE OF INTERNAL REPAIR SEALS AT COMMONWEALTH AVENUE, NEWTON, MASSACHUSETTS, USA

Date of Inspection: 23-24 August 2000

Date of Report: 30 August 2000

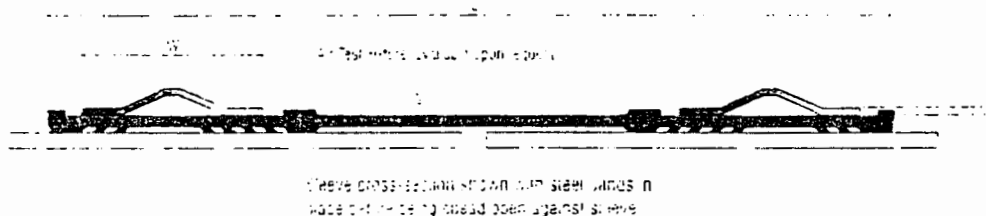
Fig 1 – Cross-section of Brico InnerSeal

- 2.3 This design allows the steel band to move laterally within the slot in the rubber sleeve. If the band was positioned at one edge of the slot, the band did not extend across all the ribs. In particular, if the steel band was against the inside edge of the slot, only one of the two outer ribs was fully beneath the band.

- 6.6 The asymmetric pattern of ribs on the Brico sleeves is something of a mystery, and the Brico personnel spoken to could not explain it. In operation, the internal pressure within the pipeline will act first on the two outer ribs, of which only one may be compressed by the steel band if the band is set to the inside of its slot. The four inner ribs may help the seal to pass a pressure test applied from the centre of the seal, but are not the first line of defence against pressure within the pipe itself. Furthermore, the asymmetric ribs may cause the outer part of the sleeve to compress more than the inner part when the jacking load is applied. This may exacerbate the effect of the taper, and increase the tendency of the steel band to move sideways.

- 6.9 The corrugated design of the Brico steel bands causes the compressive force to be applied over two bearing surfaces each approximately 0.5" wide. This is less satisfactory than a wider bearing surface where the load is spread over a greater area.

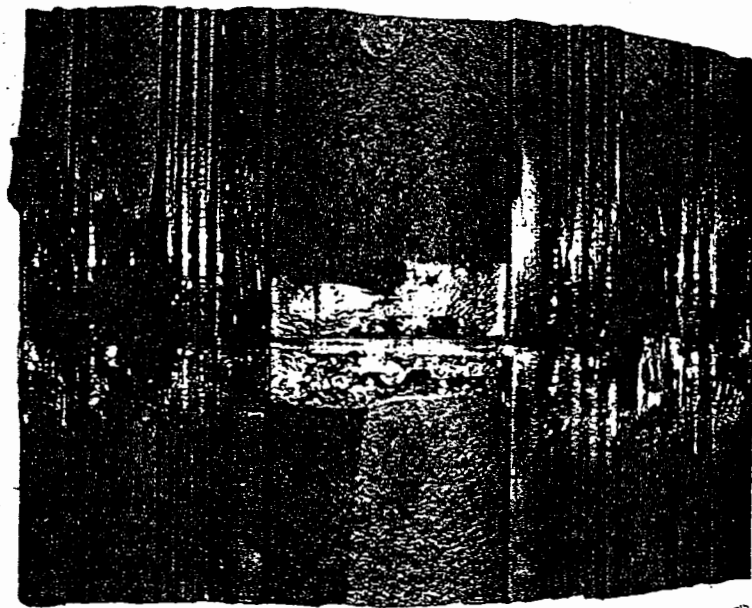
Fig 2 – Typical joint in Brico InnerSeal rubber sleeve (external face)

- 2.7 The application of the silicone sealant was generally uneven and of poor standard (see Fig 2). The sealant did not adhere well to the rubber, and could be rubbed off easily by hand.
- 2.8 It was stated that the vulcanised joint had failed in some of the Brico sleeves, and that the joint had split and come apart.

- 6.8 The vulcanised joint in the Brico rubber sleeve is evidently of lower quality than that of the Miller product. The silicone sealant seems to have been applied without much care, and is of dubious benefit since it does not adhere to the substrate and may rub off during transportation or installation. However, whilst this feature may not inspire confidence in the product, there is no evidence that this has been the cause of any failures.

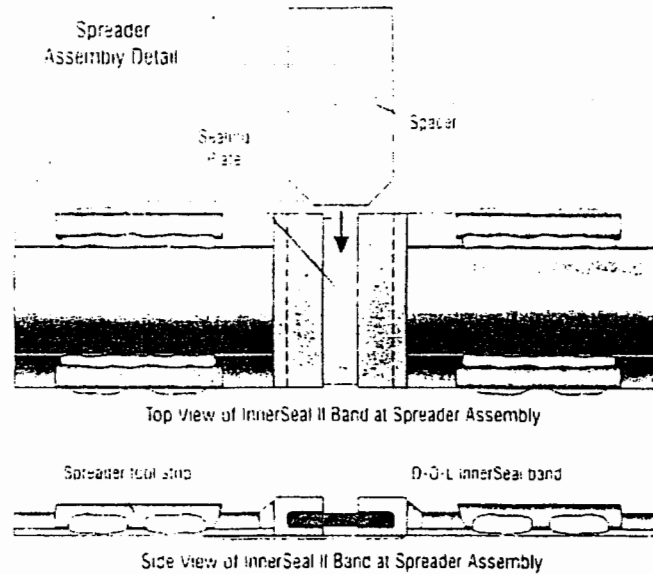
Fig 3 – Joint detail of Brico InnerSeal steel bands

- 2.10 After jacking apart, a spacer is pushed or hammered into the slots in the end blocks (see Fig 3). Welded onto the outer face of one of the blocks is a thin metal plate, intended to spread the load across the joint area where there is no direct compression from the steel band itself. Especially if the joint expansion is high, and the spacer gap is therefore large, the thin plate may have to bridge a distance of approximately 2", with no support from the band or the spacer over this length.

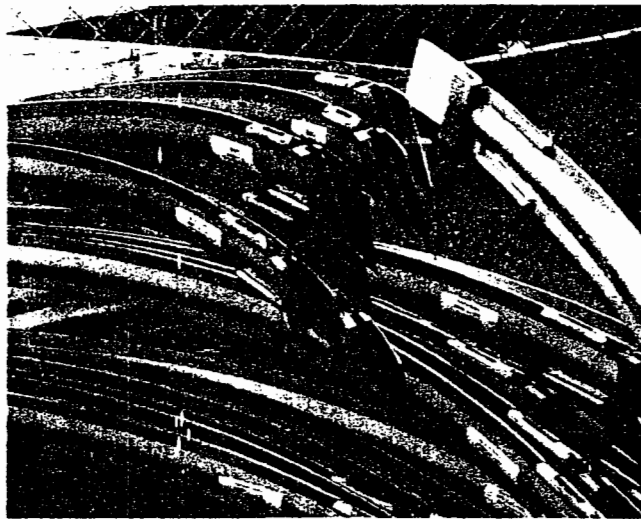
Fig 4 – Ends of Brico steel bands, showing the thin bridging plates

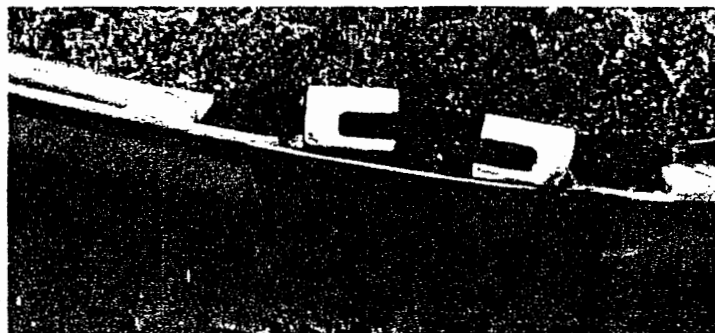
- 2.11 Some of the end blocks on the Brico steel bands appeared to have been welded on at a slight angle. In such cases, the support offered to the bridging plate may have been reduced (see Fig 5 below).

Fig 5 – End blocks and bridging plate on Brico steel band

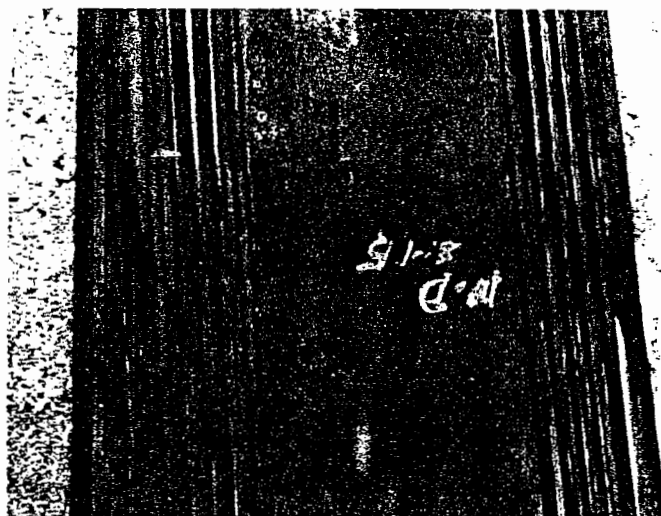
Fig 6 – Outer face of Miller seal, showing joint in rubber

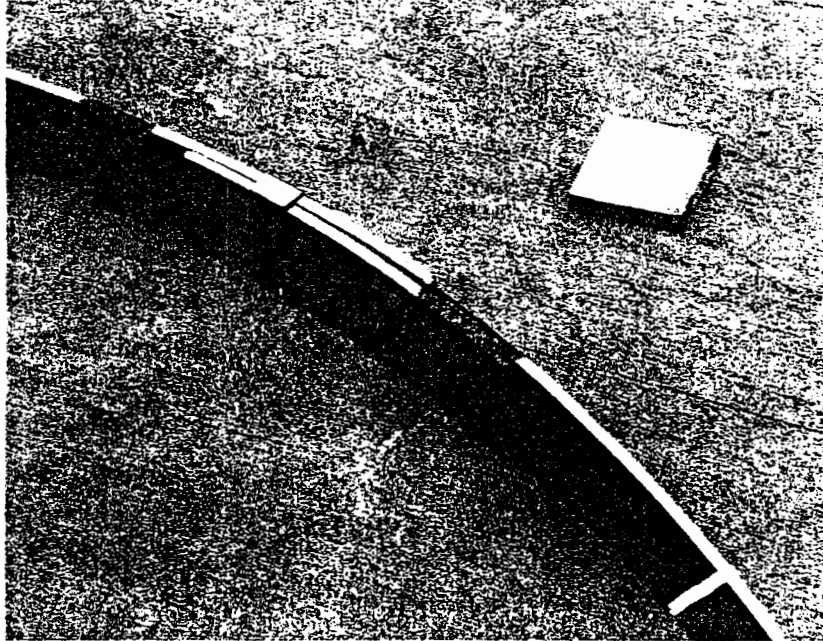
Fig 7 – Steel bands and wedge used in Miller seal

- 2.16 The Miller steel bands were in two main parts, with joints diametrically opposite. After positioning the bands within the slot in the rubber sleeve, a wedge of suitable length of was inserted at one side. A thin steel shim was then positioned under the joint at the opposite side, and the jacking load was applied here. After jacking was finished, a tight-fit wedge was hammered in to maintain the contact pressure. This wedge fitted between the main band and the thin shim which was in contact with the rubber seal.
- 2.17 The wedges for the Miller seals were cut from the same curved stock as the main band, with the objective of transmitting a fairly uniform radial force from the band, through the wedge and the thin shim, to the rubber seal.
